Melrose Fire District Existing Building Assessment

January 24, 2017

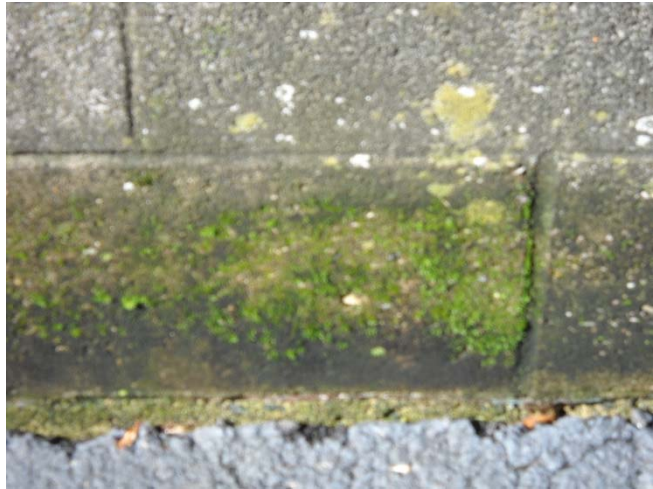
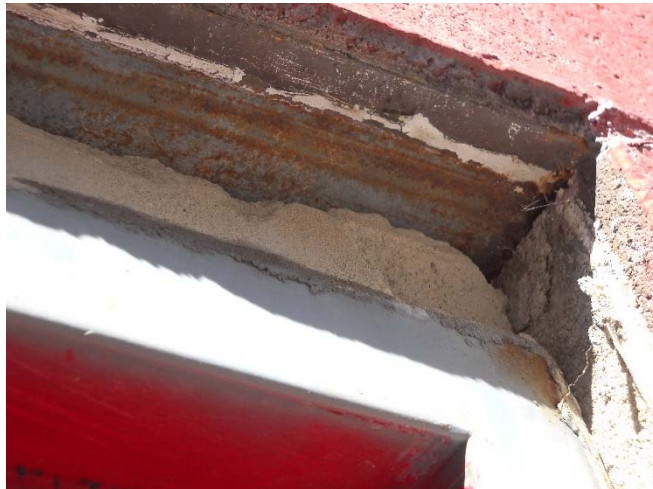
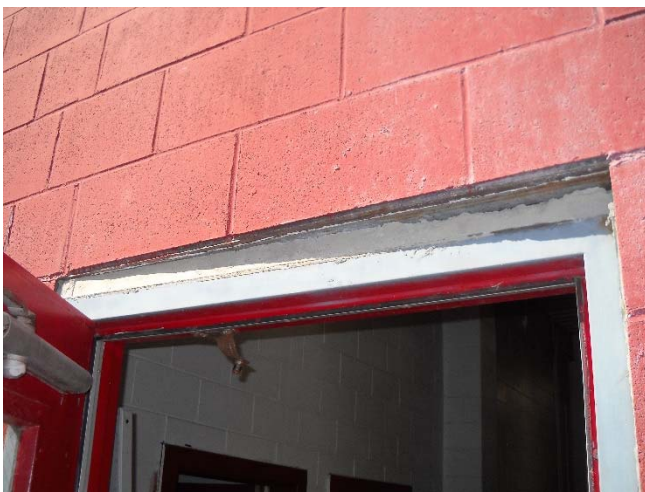
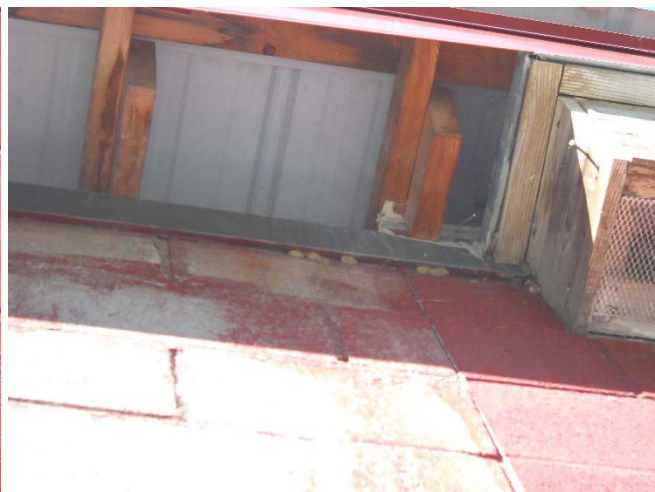
EAST ELEVATION

G/C East Elevation **Poor to Average – Wall surface and finish deterioration, Severe soffit deterioration, Door deterioration, Water damage at wall including moss growth, Needs cleaning at base of wall, Repoint, seal and/or paint, Protect from roof drainage & site drainage from hill at rear. No Insulation – Serious heat loss, Chimney deteriorated and needs to be re-pointed.**

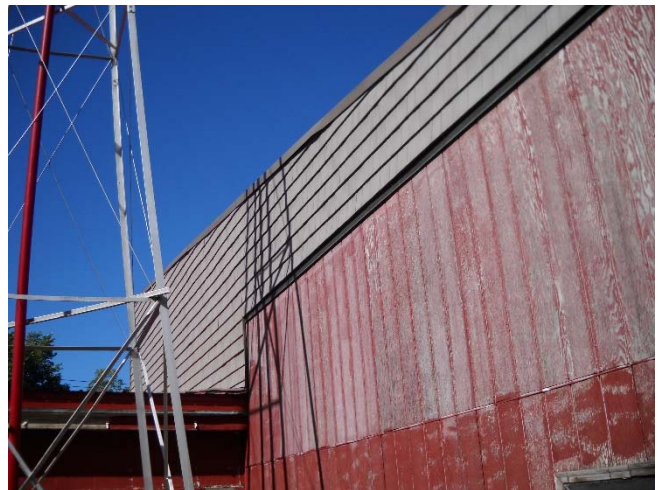
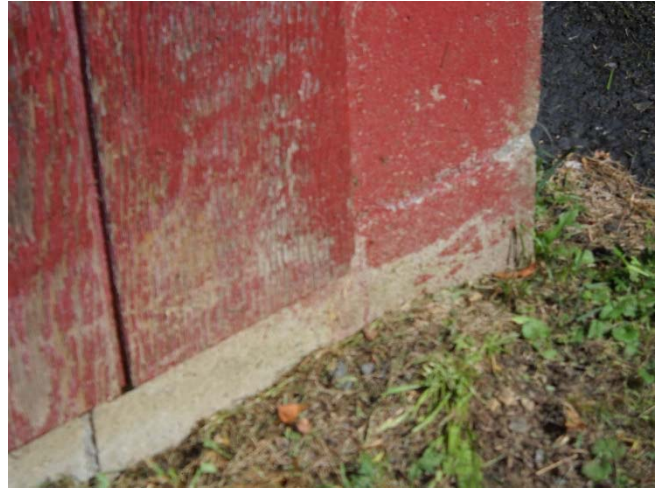
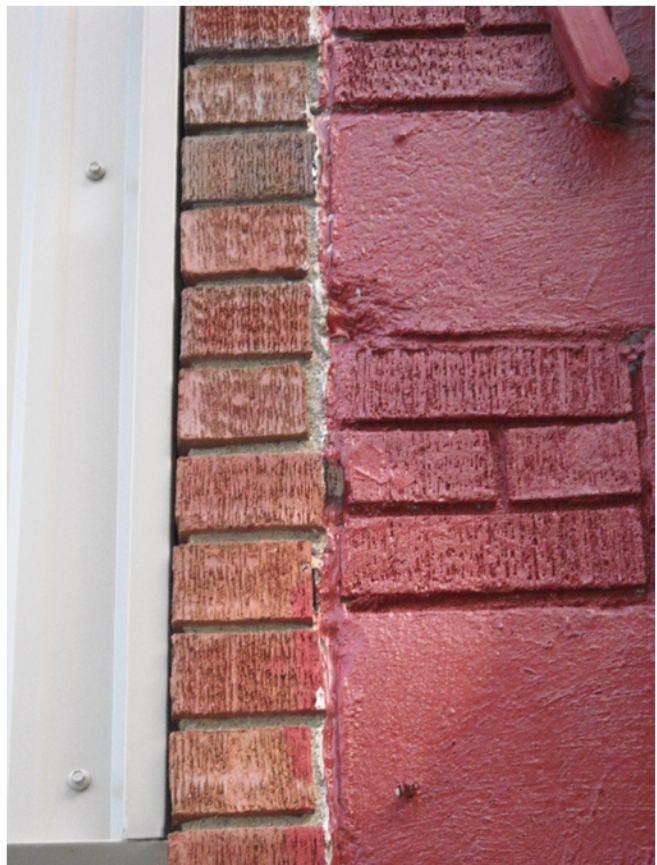
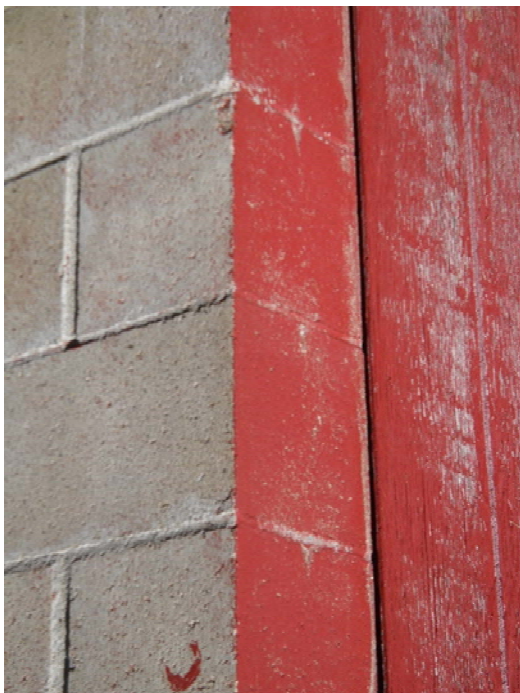
SOUTH ELEVATION

- Repoint CMU as necessary
- **South elevation** – At the base of the 1970 building CMU wall with wood siding, there is separation of the wall from the foundation. The wood wall sits on open cell CMU foundations. The open cells allow water to fill the cells in the block and can cause freeze/thaw, deterioration, etc. Dig along several areas along the west portion of the wall to inspect the foundation for deterioration. After inspection of the foundation, we will make recommendations for repair at the base of the wall.

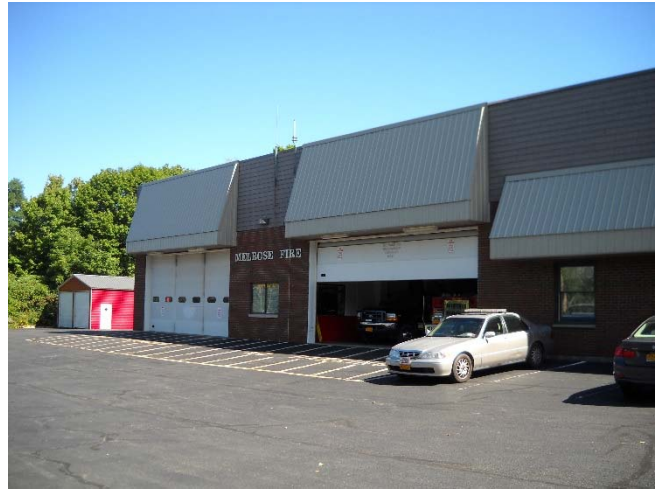
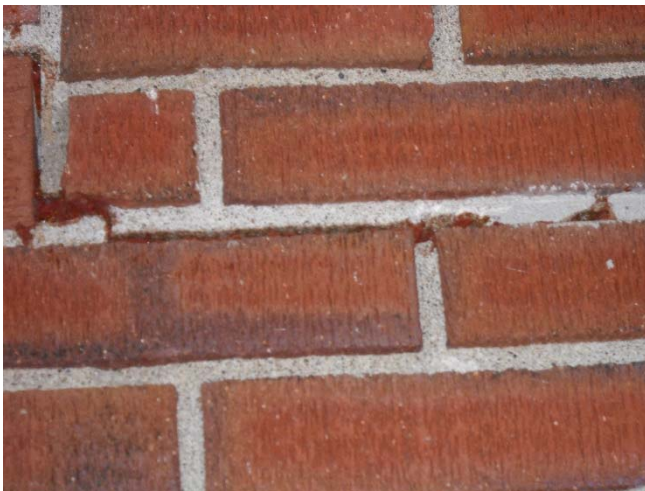
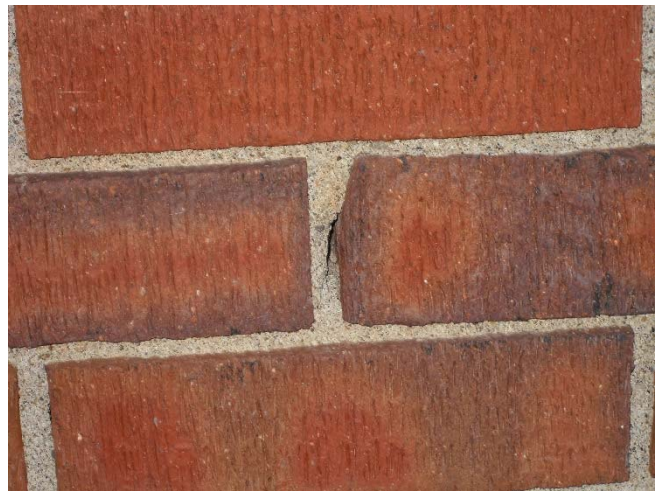
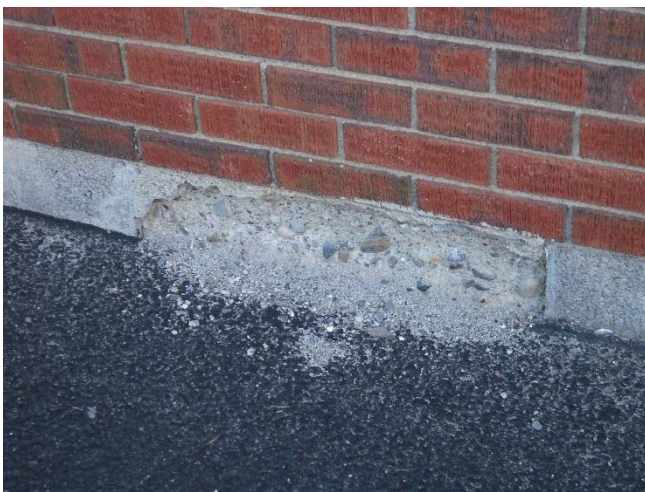
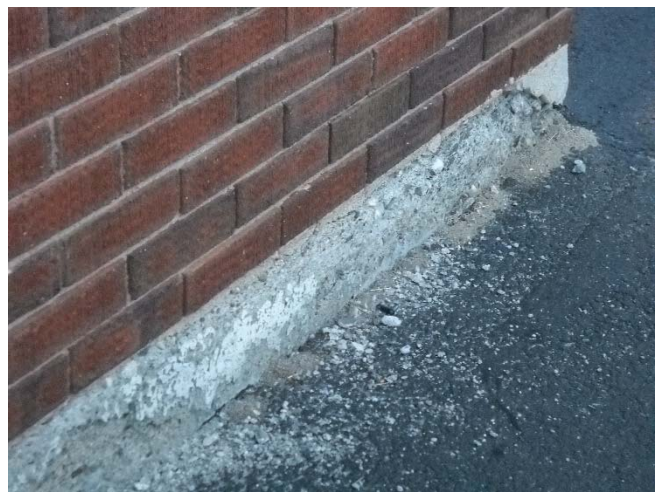
WEST ELEVATION

G/C **Brick Needs Repointing Extreme CMU Deterioration at Base of Wall. Some**

G/C West Elevation **Poor to Average. Deteriorating foundation is spalling concrete and needs immediate repair.**

G/C **Recommend Repair at Wall Base, Soffits**

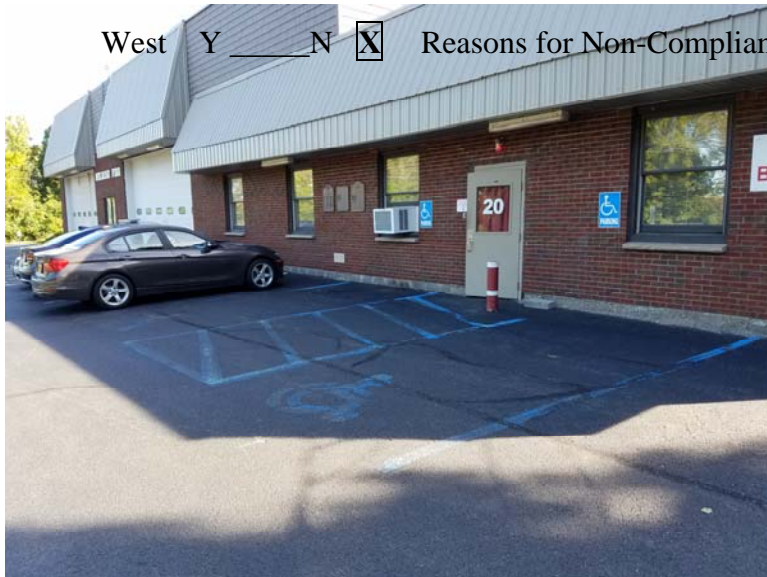
- Emergency Button 54” High
- Non ADA Door Hardware
- Air Conditioner Intrudes Into Accessible Parking Space
- Door Opening Force Too Great
- Grade Change at Threshold ≈ 3”
