MELROSE FIRE DISTRICT

Firehouse Project Facts #2

BUILDING CONDITION SURVEY

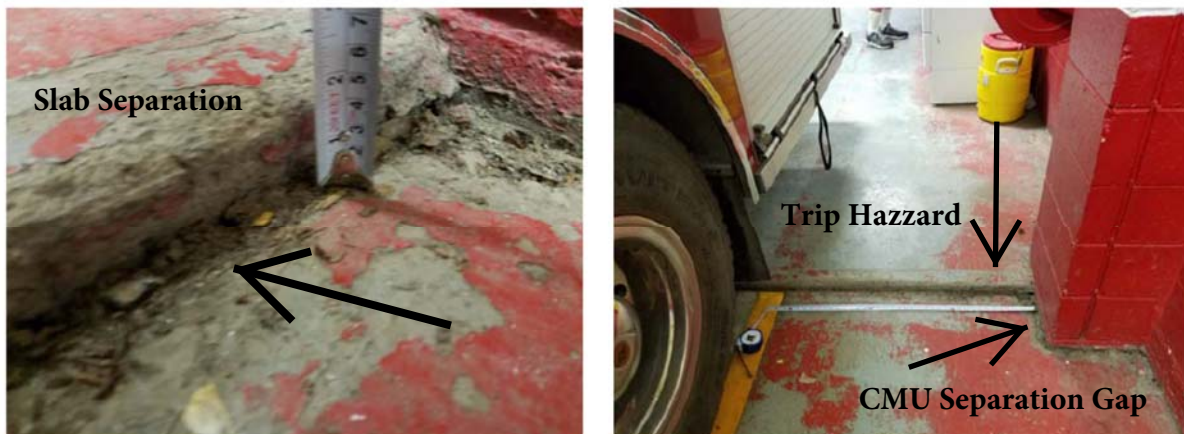
Two extremely critical life-safety concerns emphasized in the BCS report are the significant settling of the south bay floor slab and the separation of the concrete masonry unit (CMU) pilasters in that bay from their CMU anchor walls.

Specifically, decaying fill material under the apparatus bay slab is causing settling and separating in the south bay slab from the other building slab sections, resulting in a significant trip hazard that will continue to worsen. Possibly caused by organic material such as trees & stumps being mixed with the back fill soil.

NYS Building Code prohibits the use of organic materials under a concrete slab and requires that the site be stripped of all organic materials before filling. Fill material must be free of organic matter and other debris and must be properly compacted.

Apparatus Bay Floor	The most pressing issue needing repair is the bay floor and structural pilasters in the bays. The floor is a trip hazard and will continue to deteriorate. The pilasters should be pinned back to the CMU wall before there is structural movement of the support beams resting on them. There are several methods to repair the floor. A permanent fix involves removal and replacement of all unsuitable soil and organics under the slab. The only way to do this is to remove the slab and replace it onto proper compacted base. There is an unknown factor of how much and how deep the unsuitable materials are. Imagine excavation of many feet of materials to try and reach virgin ground. The unknowns associated with this type of fix could present untenable budget problems.
---------------------	---

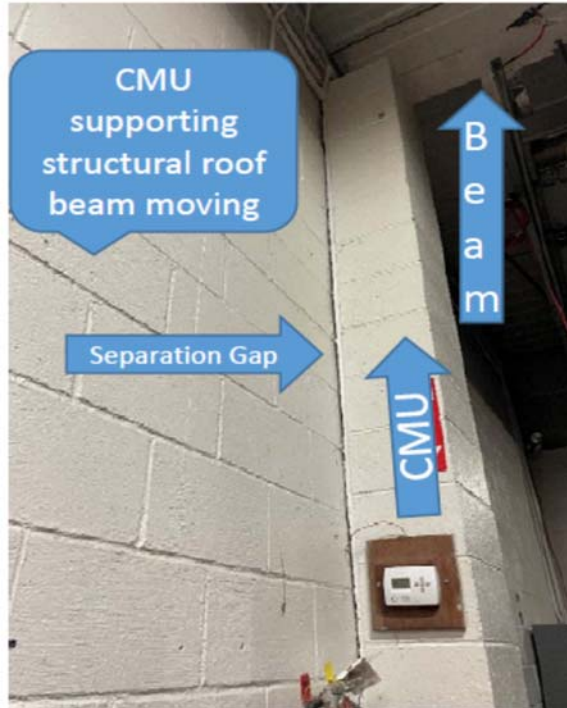
Even more concerning, this settling has created underground voids below the bay slab, causing the CMU pilasters that support the structural roof beam to separate from the CMU wall. Continued movement or a complete collapse of the CMU pilaster will create a dangerous safety condition by weakening the roof support beam system.

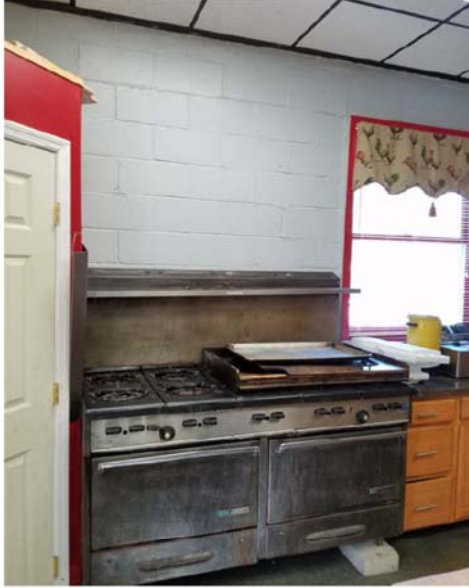
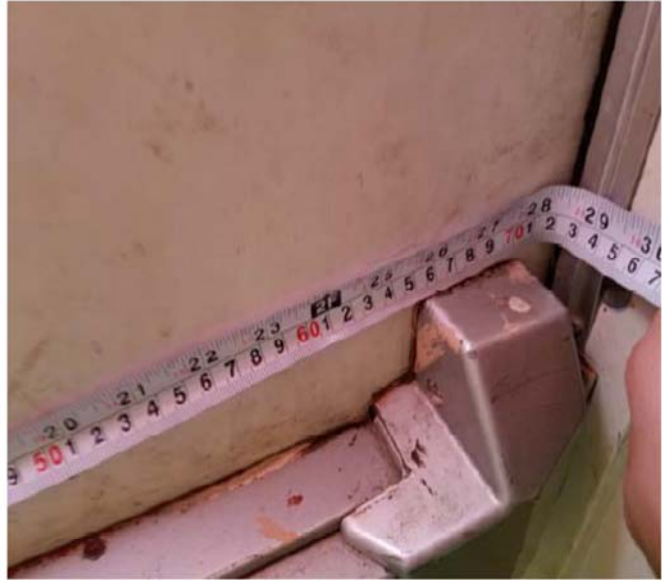
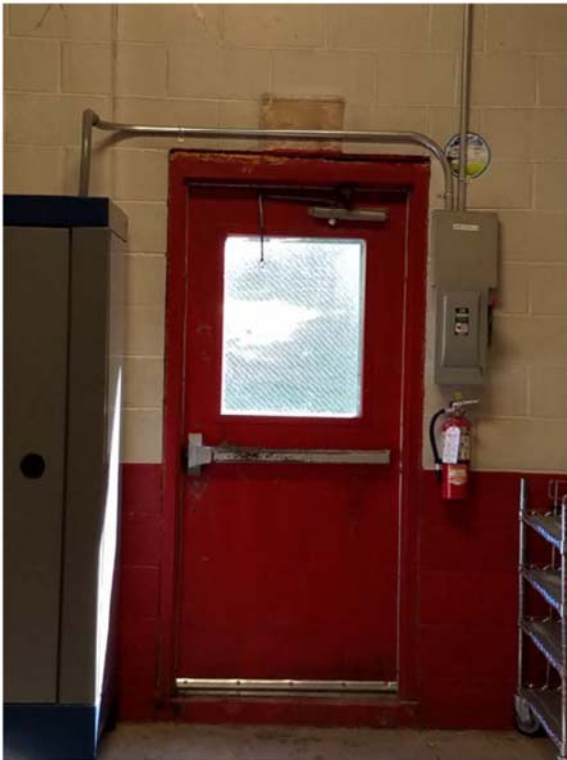
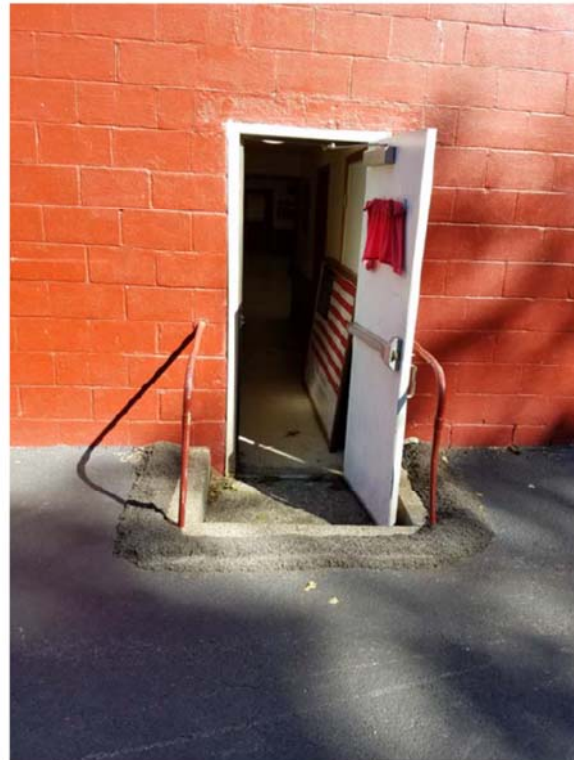
The BCS also documented multiple building code compliance conditions, including no fire alarm system, no kitchen hood fire suppression system, no sprinkler system and multiple hallways that do not meet the required width. ADA compliance issues included, non-accessible bathrooms, non-accessible entrances, non-compliant door handles and non-compliant door thresholds.

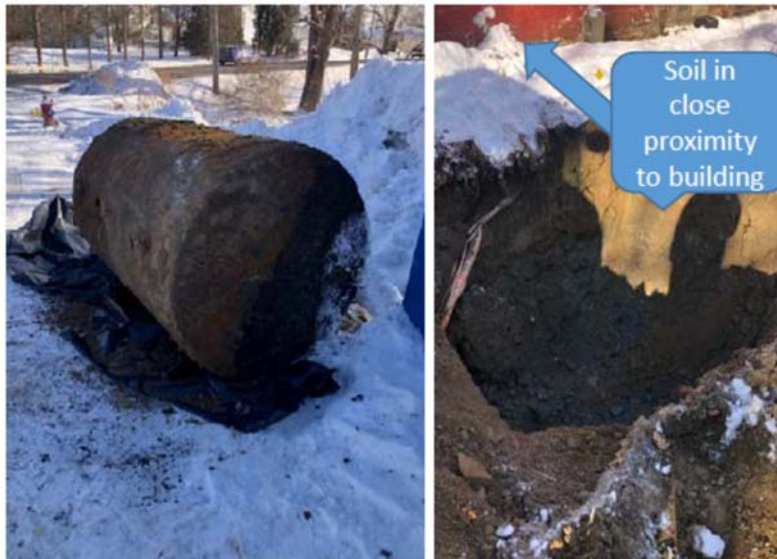
Following the BCS, a site assessment was performed by the environmental engineering firm CT Male. The site assessment identified a leaking underground fuel oil storage tank, causing below grade soil contamination. The fuel oil leak was deemed to be reportable as a spill incident to the NYS Department of Environmental Conservation (NYSDEC), necessitating a remediation plan that has to date, resulted in removal of the leaking tank and excavation of some contaminated soil. NYSDEC has authorized a plan to remove the remaining contaminated soil as a component of this

project, since at this time, further excavating the soil abutting and under the building's foundation may lead to destabilizing the existing firehouse.

Hot Zone and Cold Zone Cross Contamination	Create zones within the facility to try to limit carcinogens from the apparatus area "hot zones," from administrative and public area "cold zones." Develop "standard operating procedures," various cleaning protocols, special layouts, specially designed "transition zones," and HVAC design to move from zone to zone. The goal is to manage or eliminate the level of exposure to contaminants and ensure carcinogens do not make their way into the cold zones of the facility.
Code/ADA Matters	Building code and ADA noncompliance create unsafe conditions that can lead to personal injuries, resulting in possible civil liability and/or property damage that can inhibit the District's ability to properly deliver services to the community. These items require a high priority response.
Underground Fuel Storage Tank (UST)	It is recommended that the 500-gallon UST be properly closed. Proper closure shall include emptying the tank of bulk liquids, proper disposal of these contents, swabbing the interior of the tank, and recycling of the steel tank carcass upon removal. During the tank removal activities, an assessment of the excavation's floor and walls must be completed to determine the level of petroleum impacted soil removal required to meet NYSDEC requirements. Samples of the excavation floor and walls are required to be submitted for laboratory analysis for documentation of the soil quality being left in-place. Impacted soils removed from the tank grave shall be properly characterized and then disposed of at a facility permitted to accept this type of waste.
