Melrose Fire District Existing Building Assessment

January 24, 2017

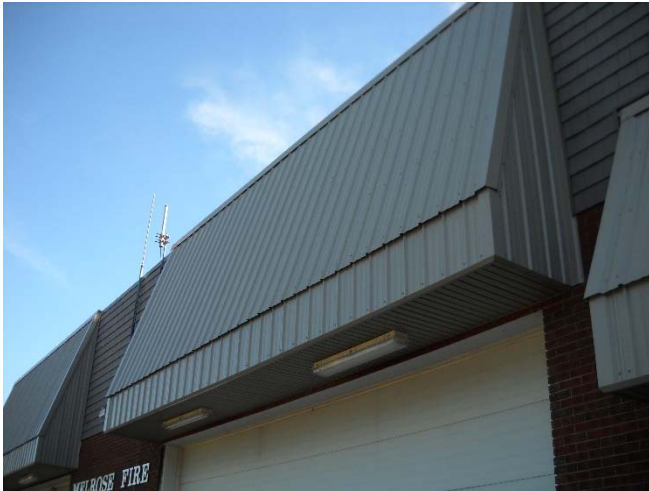
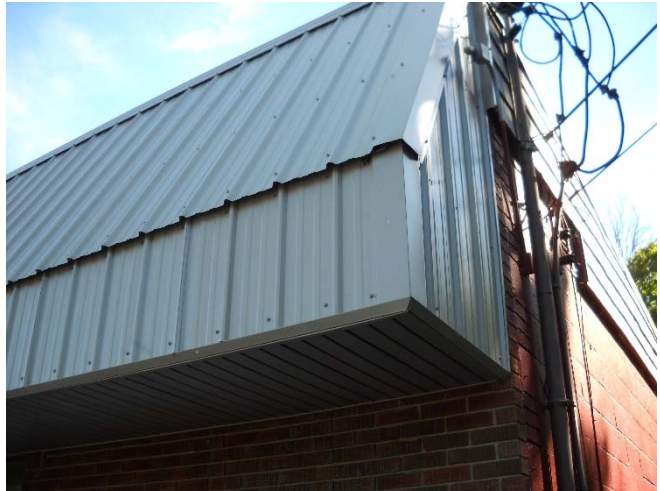
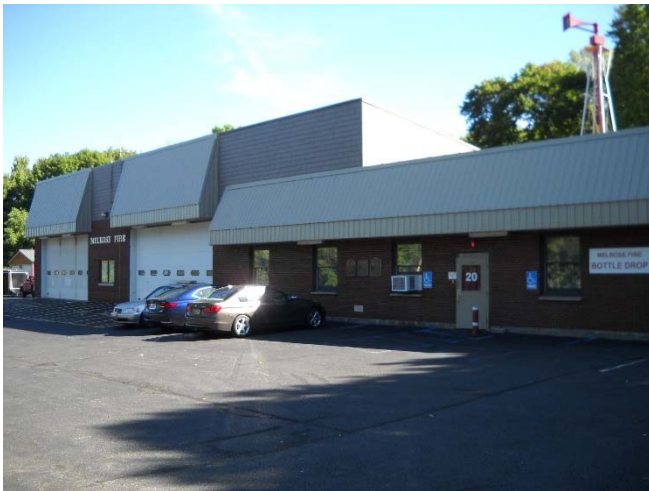
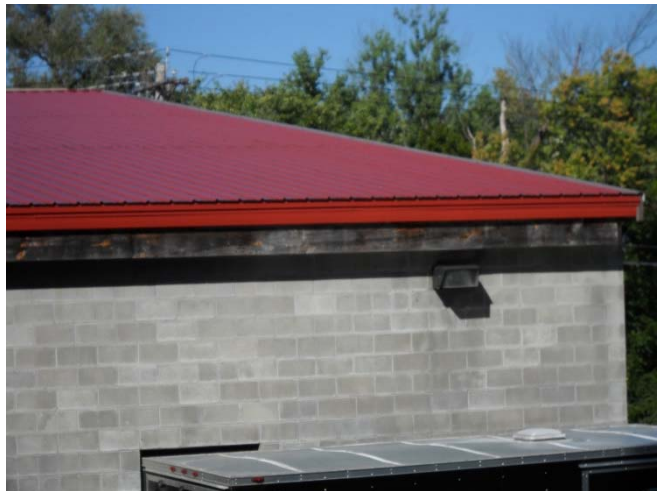
ROOFS

Roofs: # of Different Roofs **Two distinct roofs with multiple layers – 5 year old ribbed metal installed directly over Bitumen Roof.**

G/C **Direct flow off of roof which runs down exposed fascia and wall, splashes onto wall – deterioration at wall and at wood sub-fascia.**

G/C Roof #1 **Good – Consider large gutter with downspouts to direct flow away from wall. Repair/replace and paint or aluminize wood fascia.**

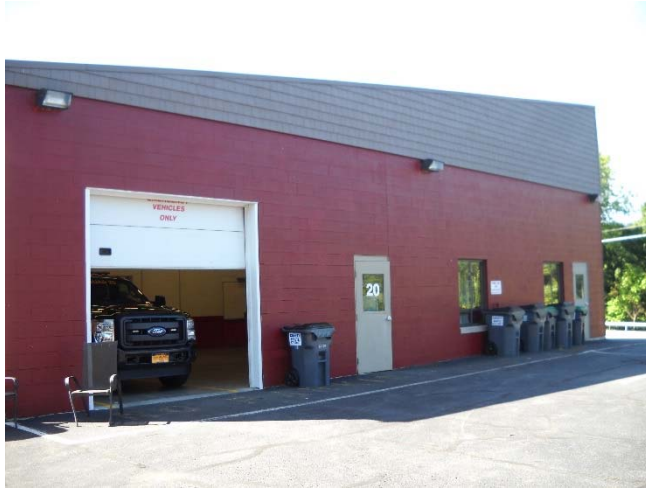
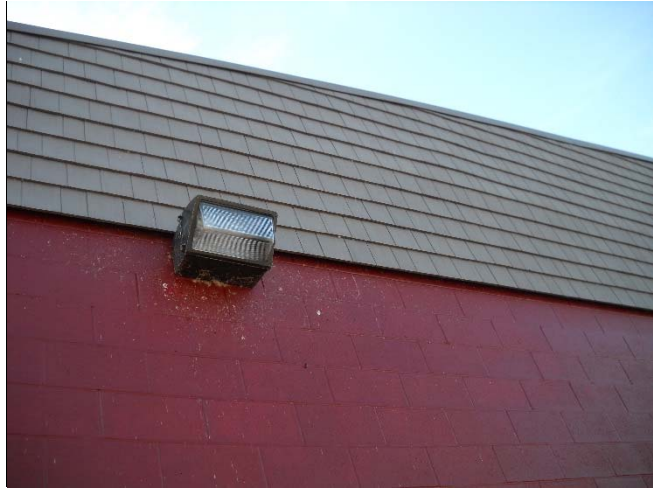
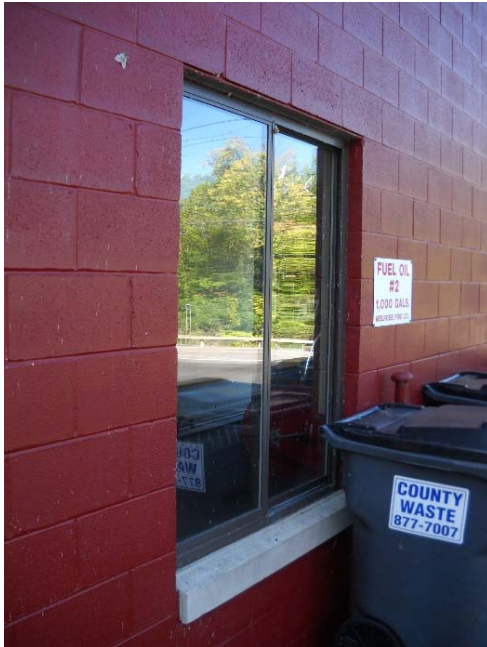
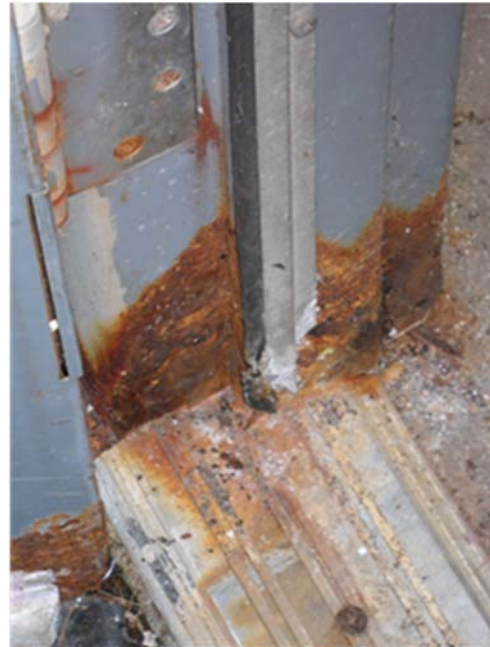
NORTH ELEVATION

General Condition Exterior Skin G

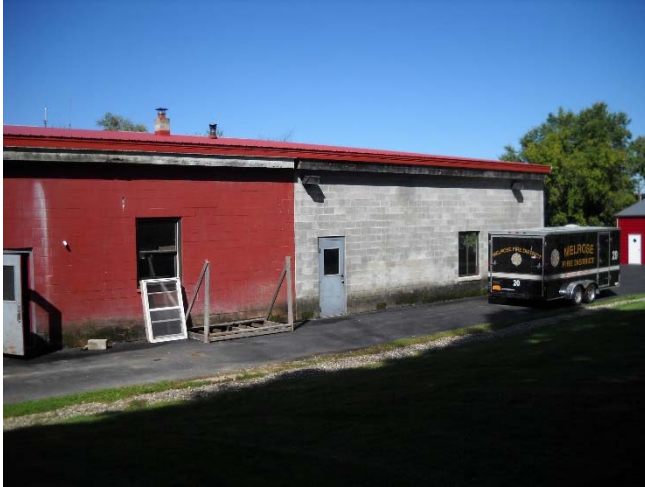
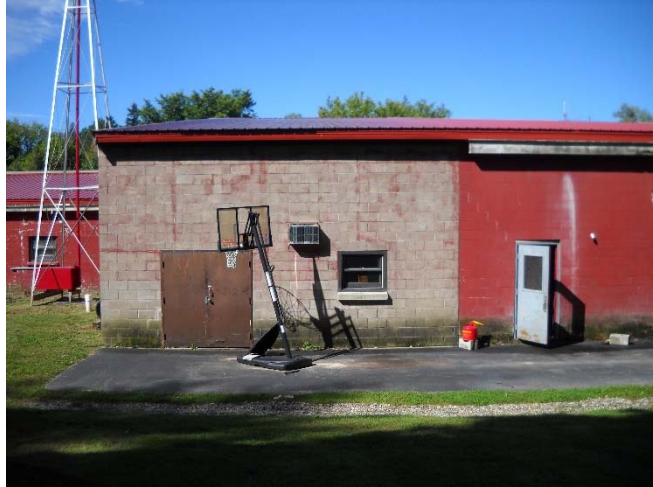
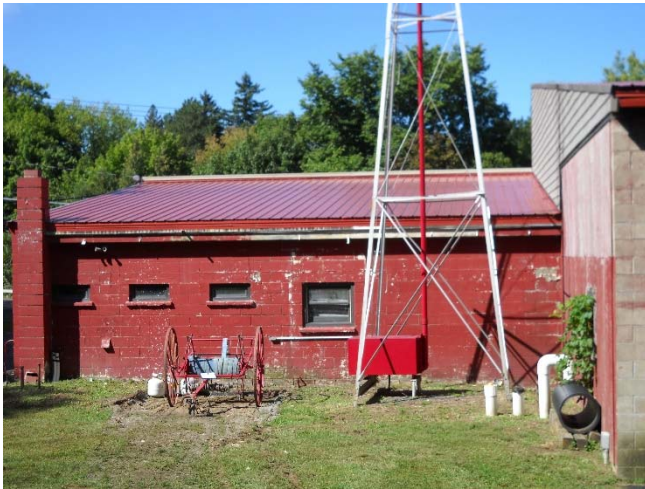
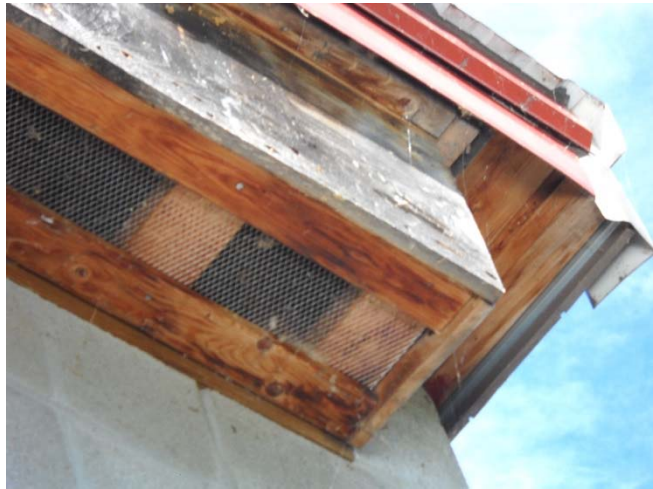
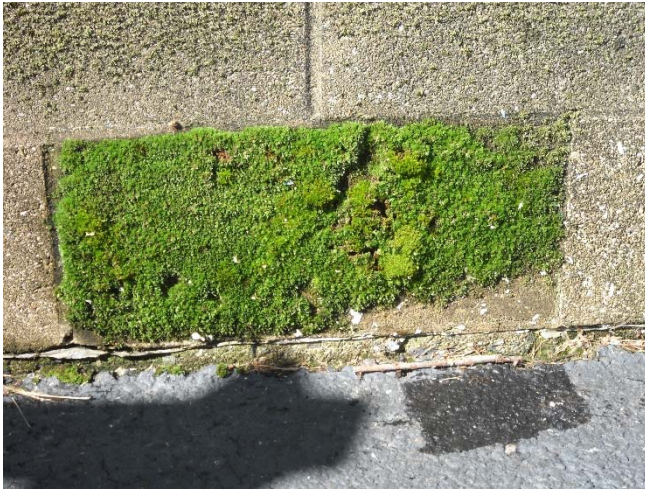
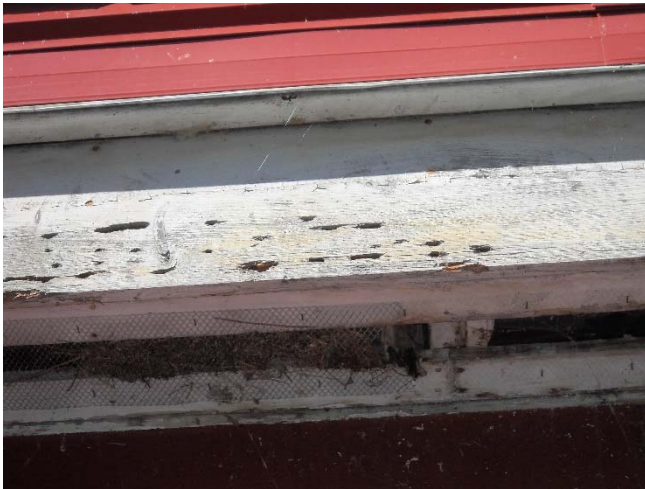
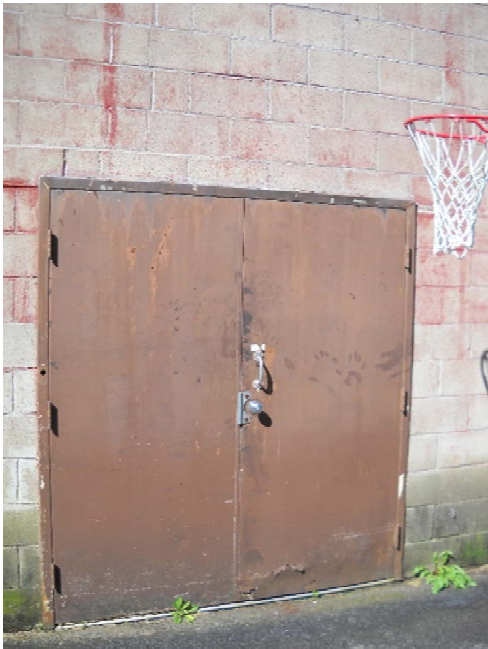
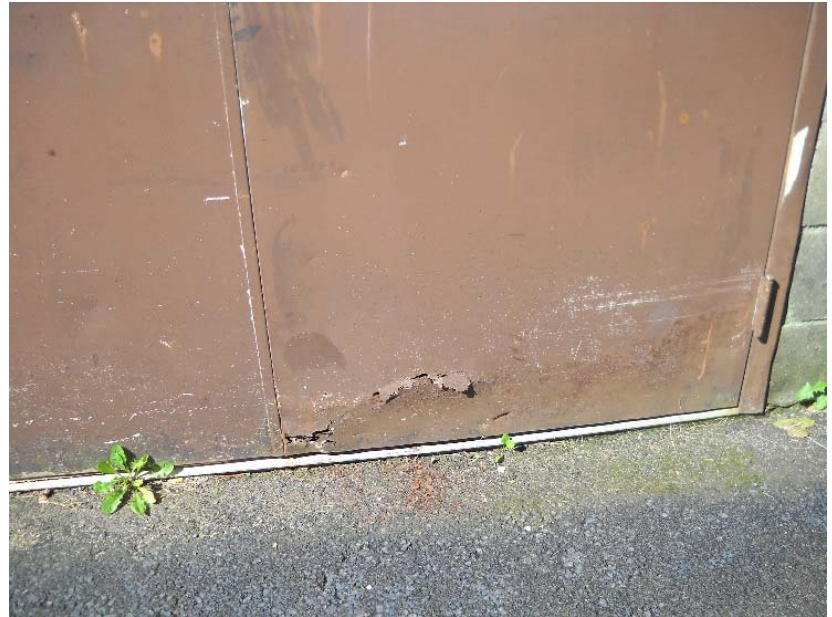
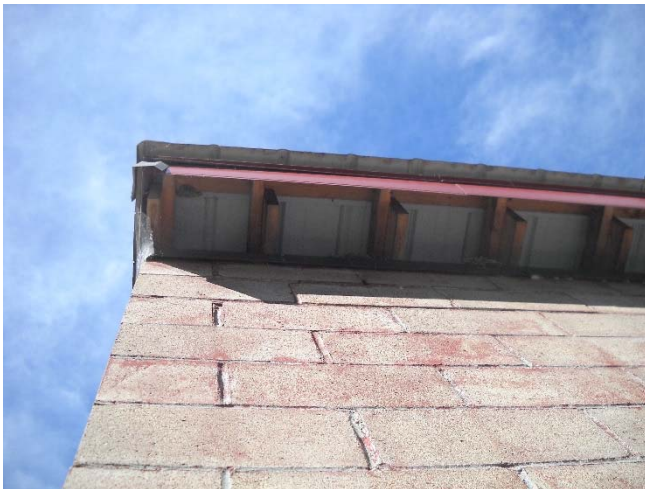
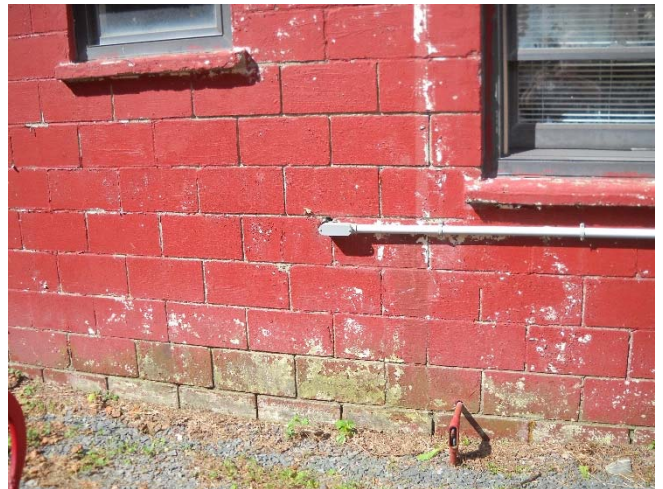
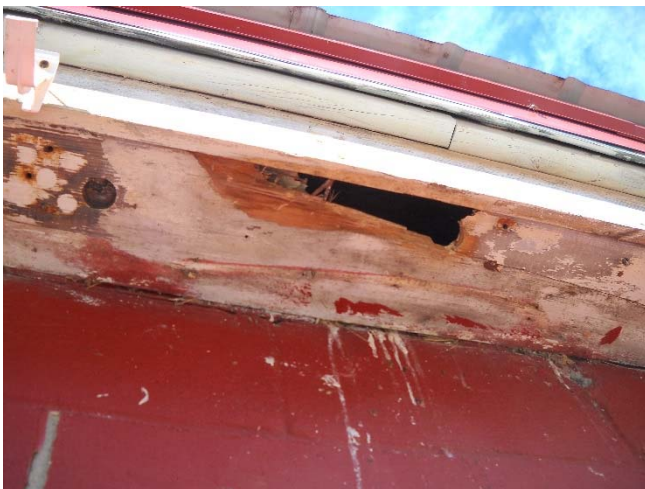
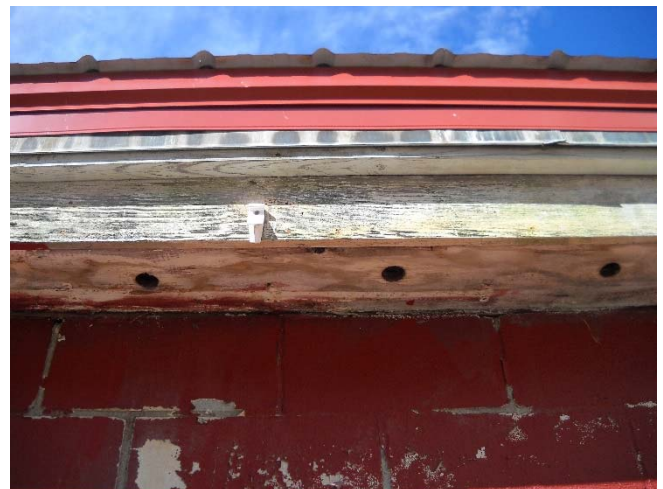
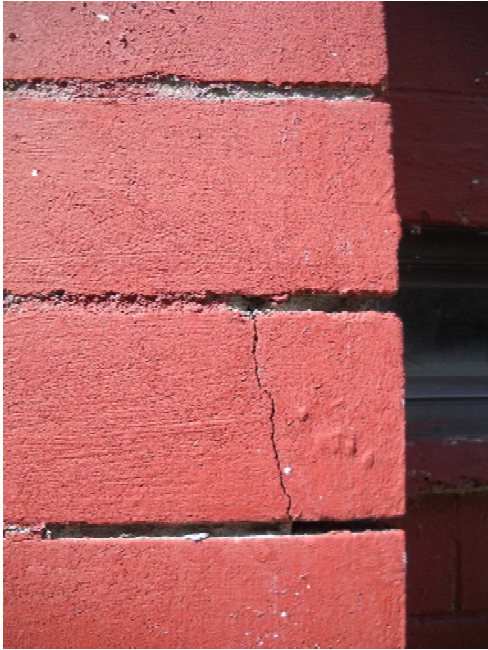
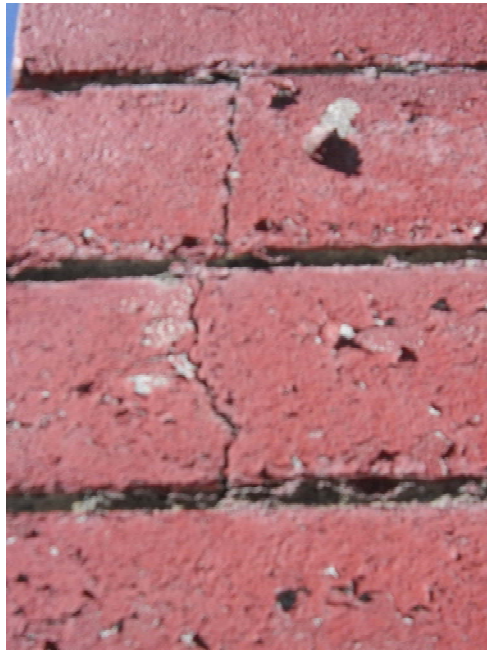
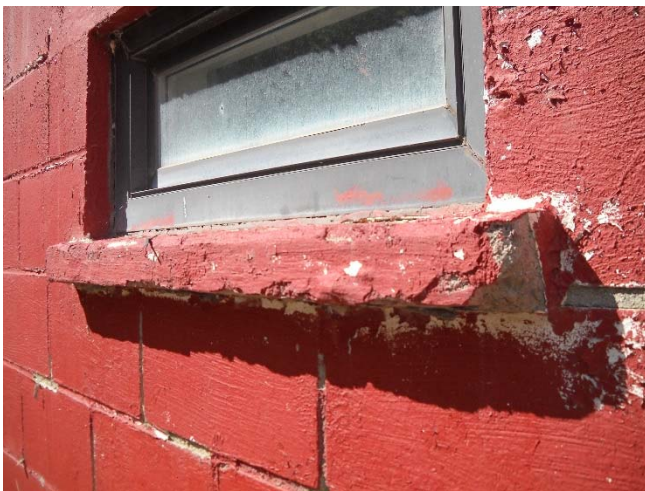
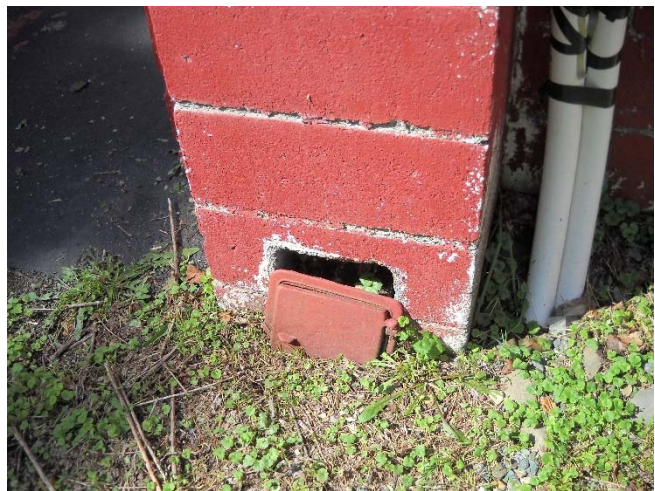
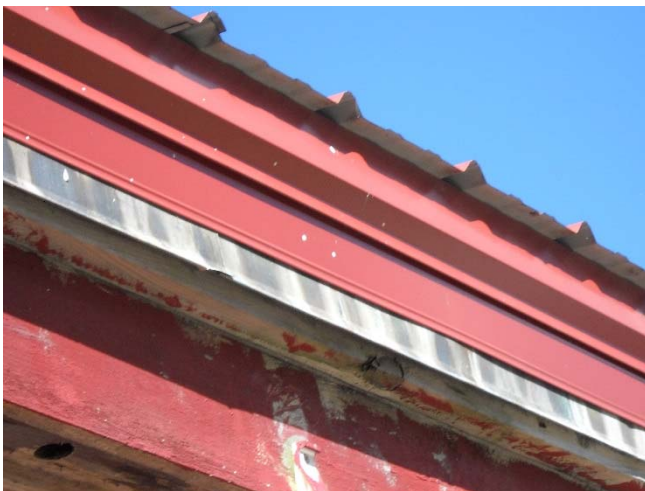
EAST ELEVATION

East Door Frame Rusted at Bottom – Serious

General Condition Exterior Skin: **P** - Some Painted, Some Plain

All Soffits & Vents – X – Remove & Replace or Missing

Closure – One Missing/One is Disconnected **Sweeps**

Separated from Wall – Double Doors deteriorated and severe leaks X -Remove & Block Up Opening –

G/C East Elevation **Poor to Average – Wall surface and finish deterioration, Severe soffit deterioration, Door deterioration, Water damage at wall including moss growth, Needs cleaning at base of wall, Repoint, seal and/or paint, Protect from roof drainage & site drainage from hill at rear. No Insulation – Serious heat loss, Chimney deteriorated and needs to be re-pointed.**

G/C **Varies: Remove and Replace sealant and repair windows in 1953 original building – Repair middle window, North two windows are O.K.**

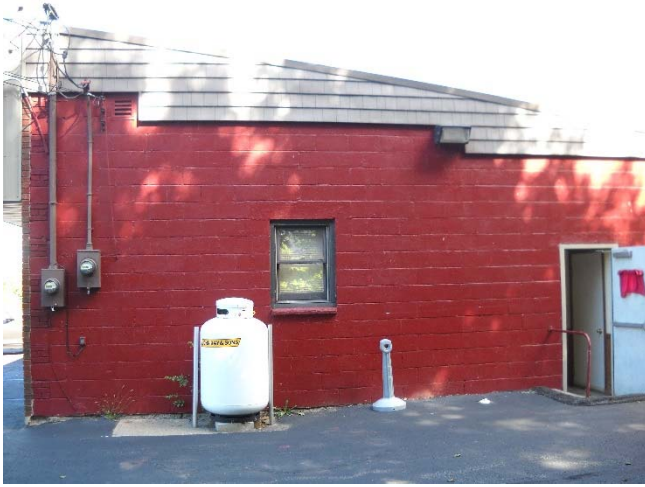
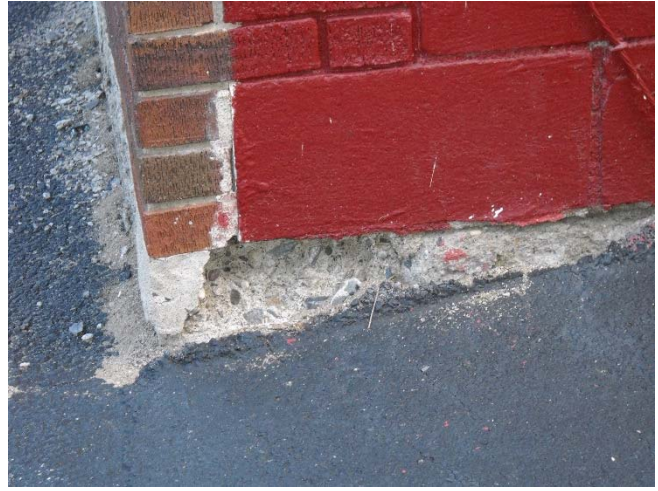
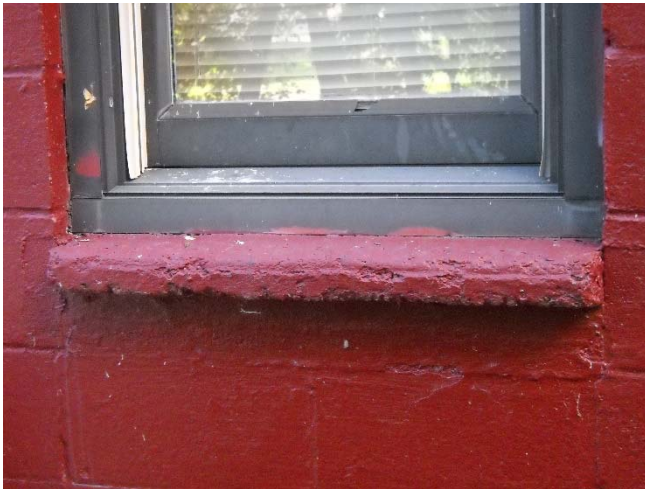
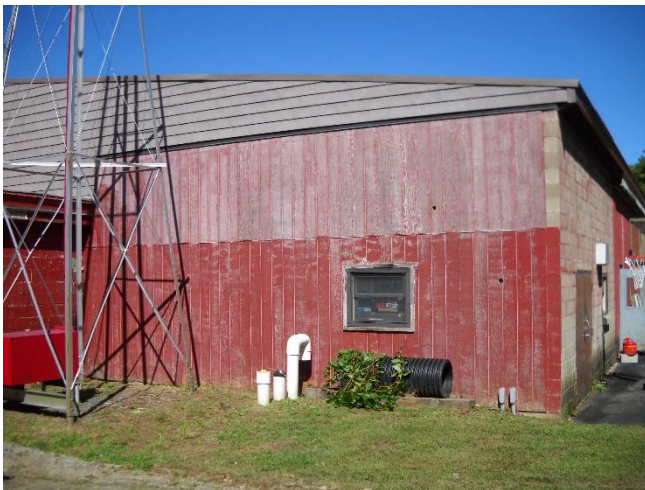
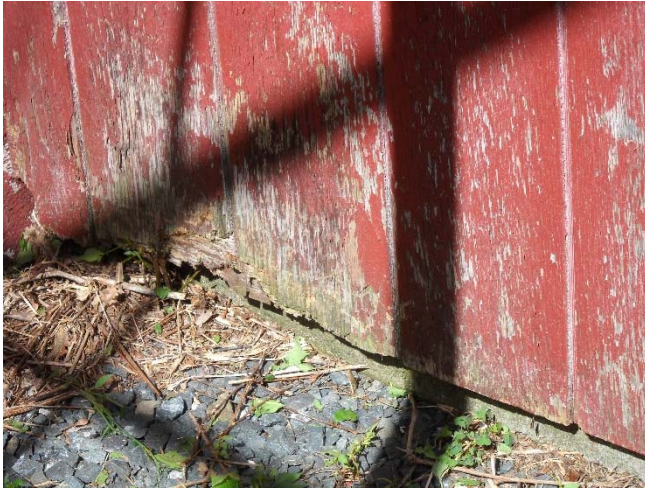
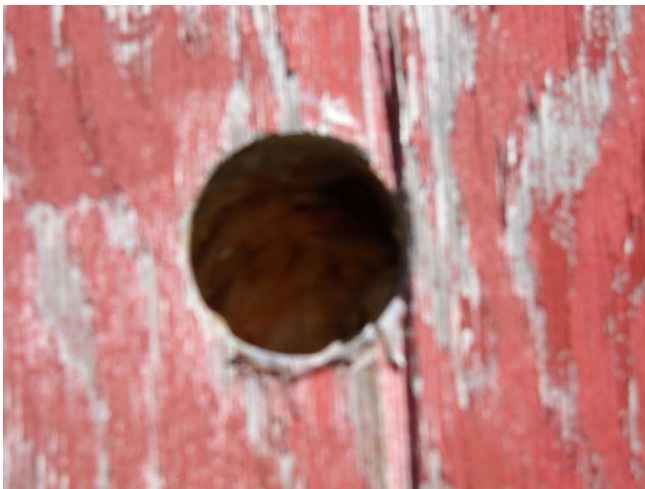
SOUTH ELEVATION

General Condition Exterior Skin: **P**

Open CMU Foundation

G/C **Deteriorated**

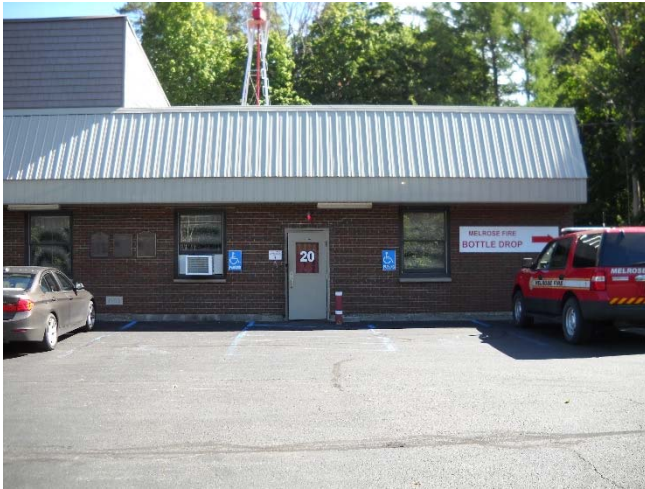
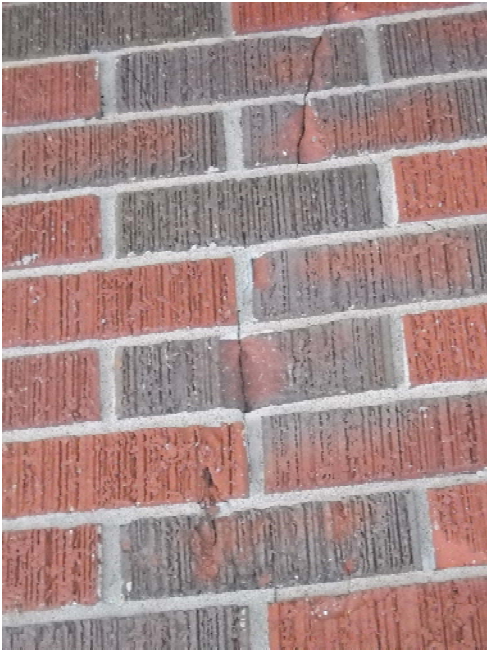
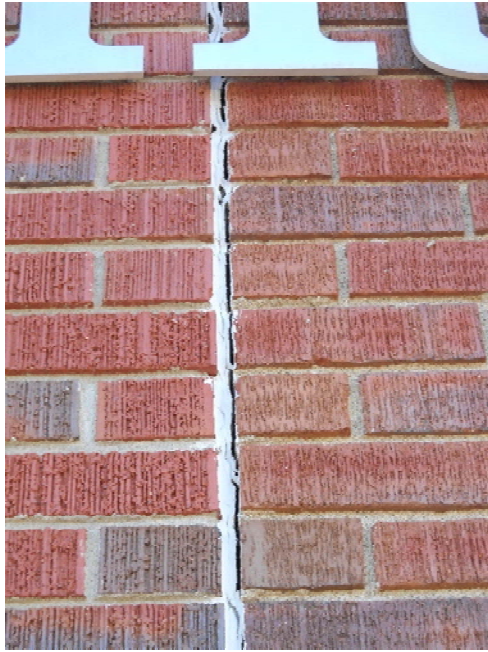
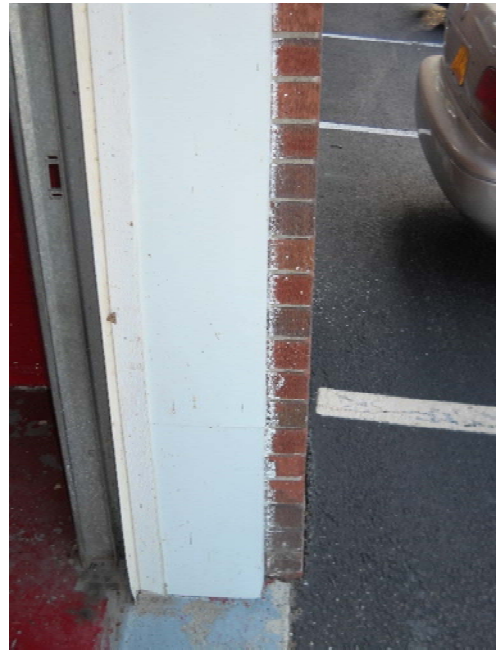
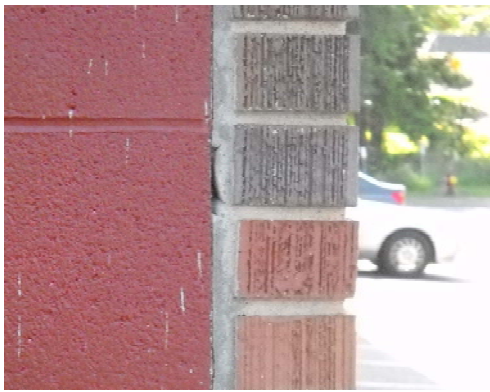
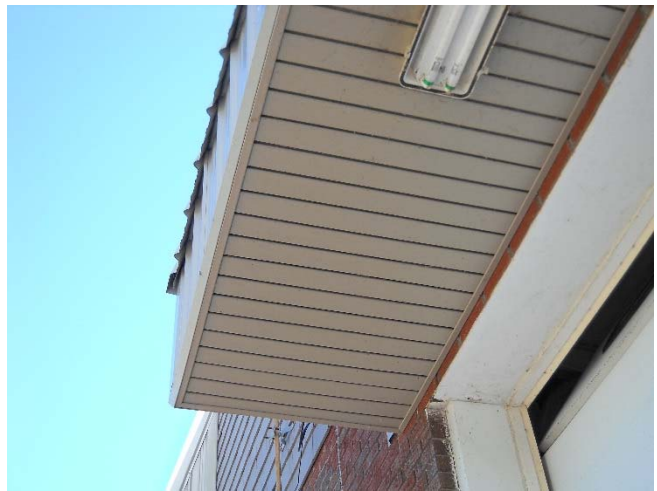
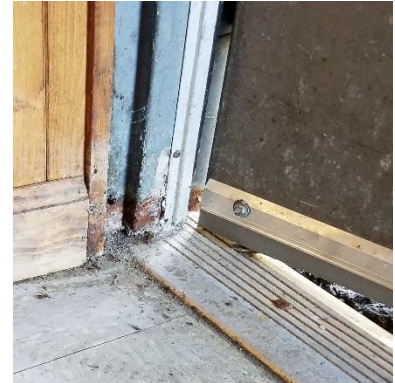
WEST ELEVATION

G/C **Brick Needs Repointing Extreme CMU Deterioration at Base of Wall. Some**

G/C **One - Needs Remove & Replace Sealant**

G/C Doors: X HM Frames rusted at bases

G/C West Elevation **Poor to Average. Deteriorating foundation is spalling concrete and needs immediate repair.**

G/C **Recommend Repair at Wall Base, Soffits**

G/C **Clean & Inspect Sealant**

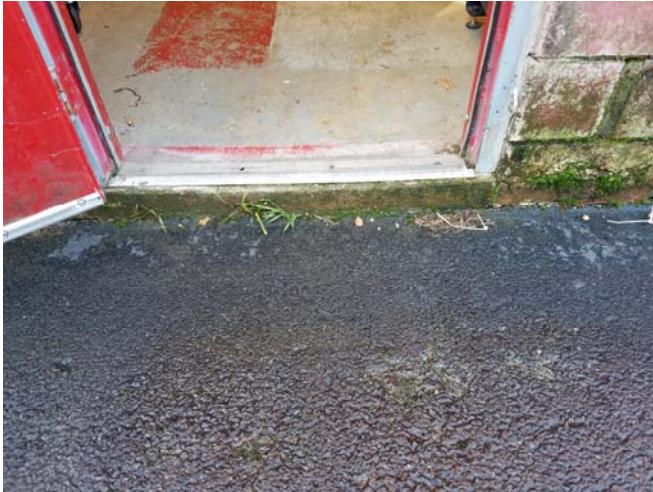
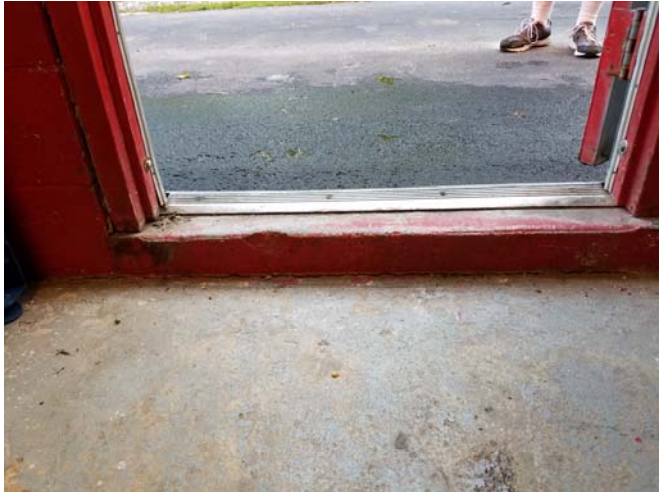
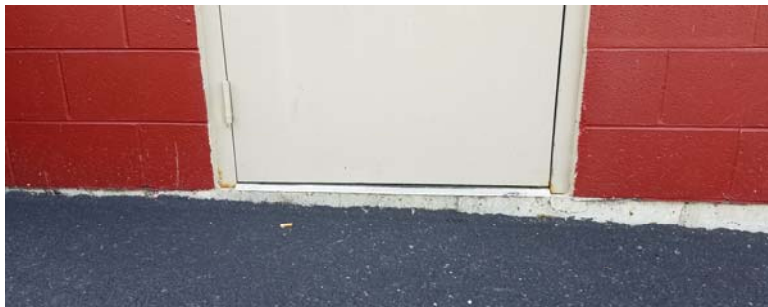
- Emergency Button 54” High
- Non ADA Door Hardware
- Air Conditioner Intrudes Into Accessible Parking Space
- Door Opening Force Too Great
- Grade Change at Threshold ≈ 3”

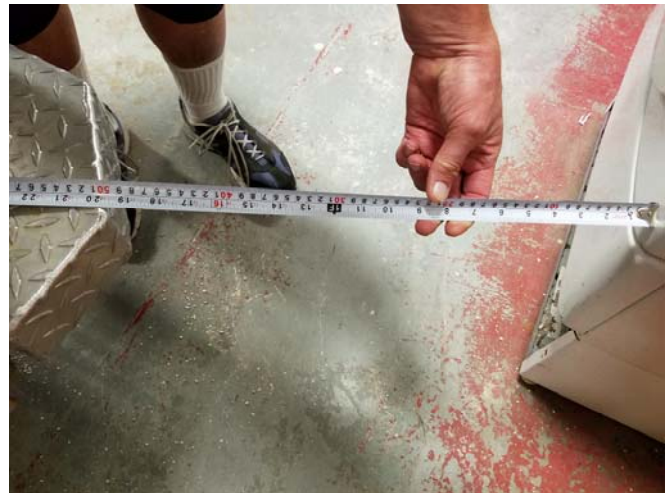
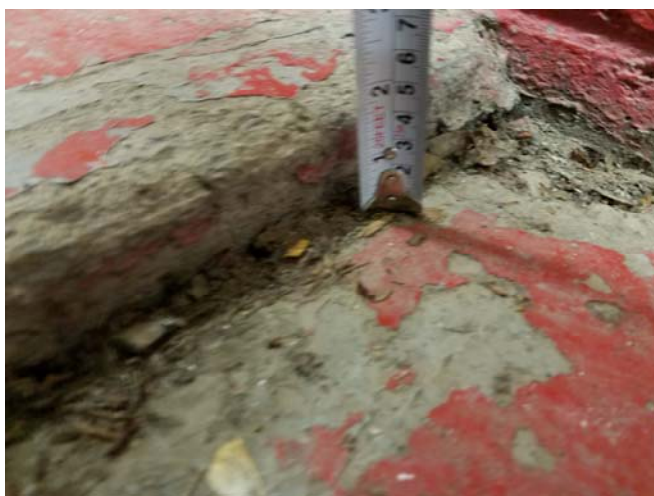
Egress: **Too Much Force to Open Panic Device, Inadequate Egress Width, East Egress Door Trip Hazard, No Exit Sign or Closer at East Door from Turnout Area.**

Life Safety: **Raised slab trip hazards, drainage in response and egress paths, No exit sign at door, North Egress Door (East) from Bays Does Not Open In Winter With Frost Heave.**

FA168: Less than 3' Clear Around Trucks, Drains Not Under Trucks, Trip Hazards

NYS: Broken Closer at Egress Door

No Access to Mezzanine

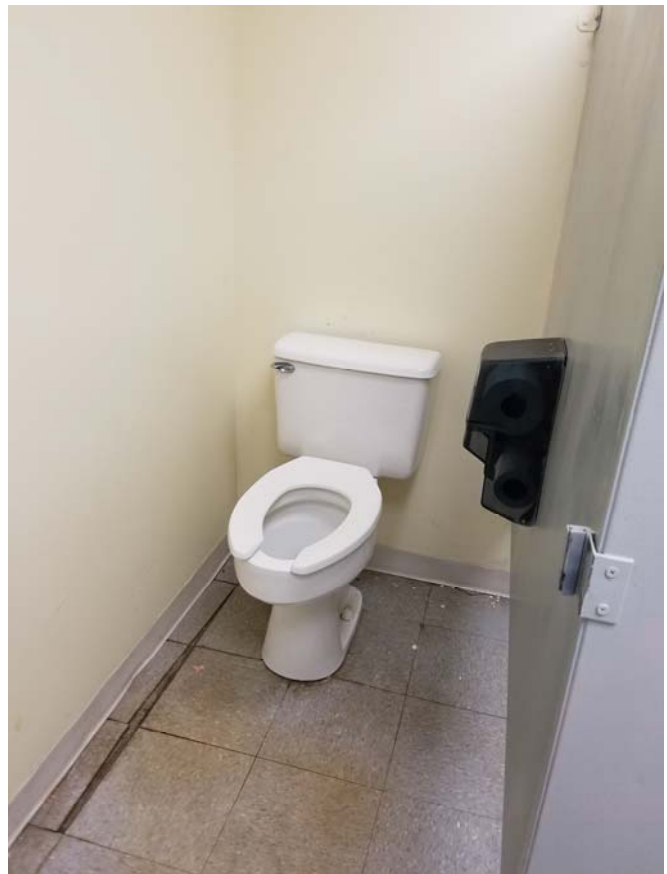
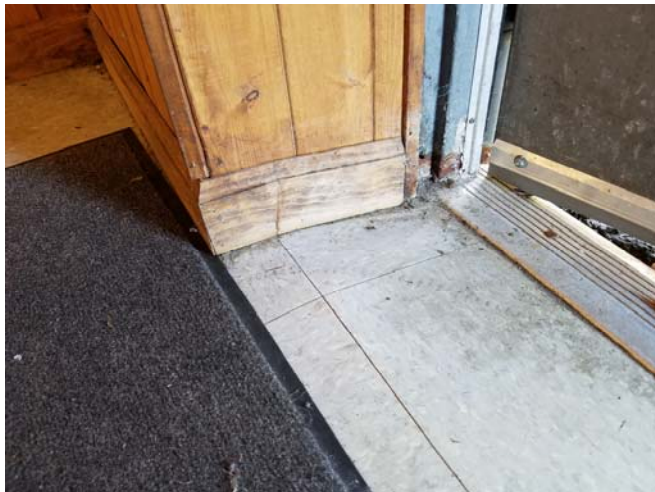
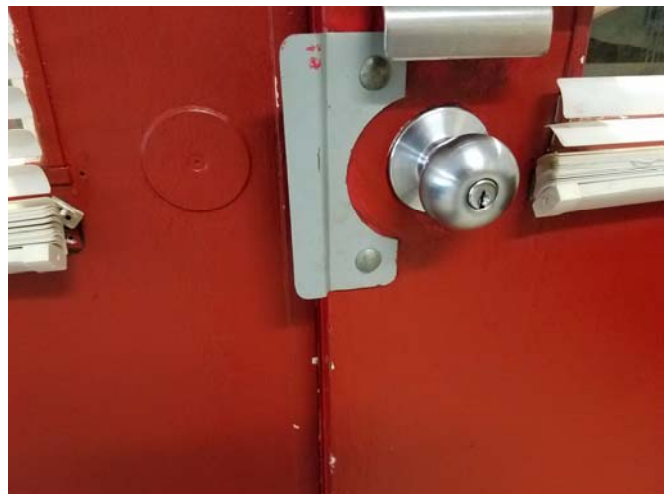
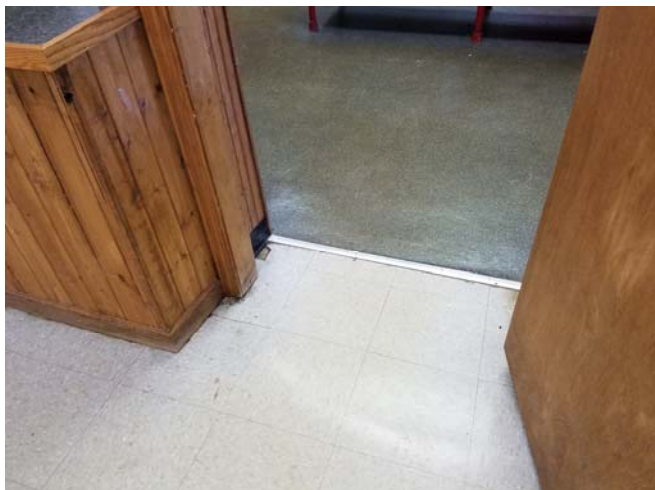
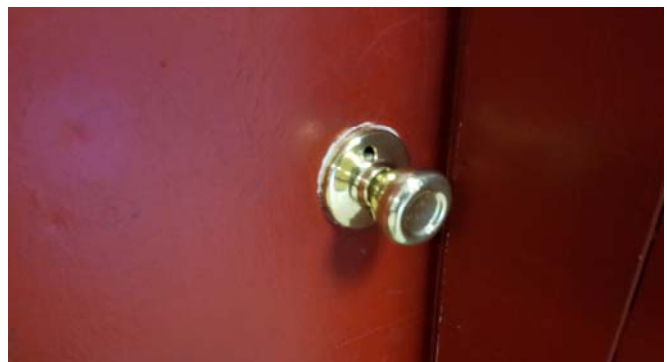
**Non Compliant Ramp Between Meeting
Room & Kitchen**

Non Compliant Door Knobs

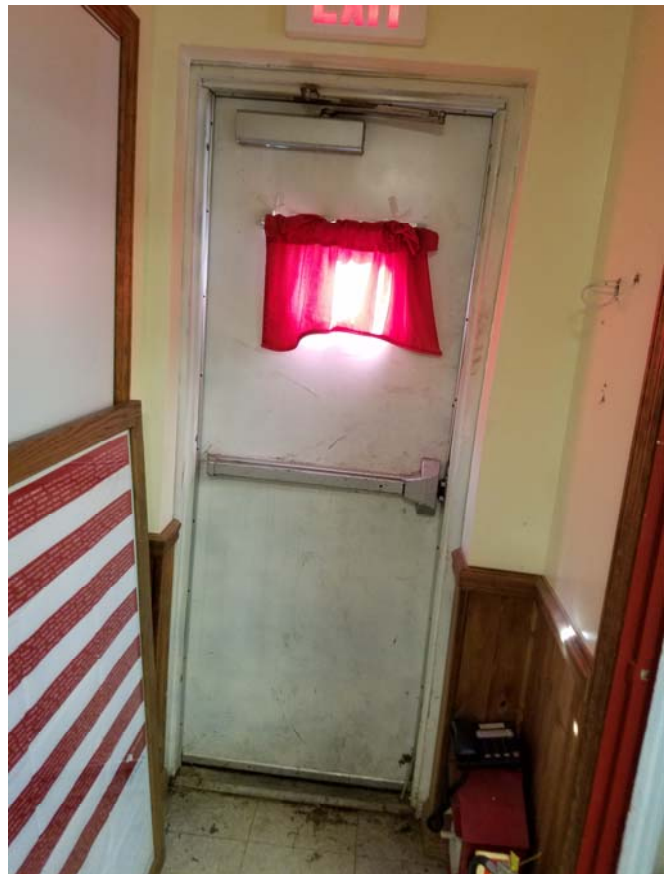
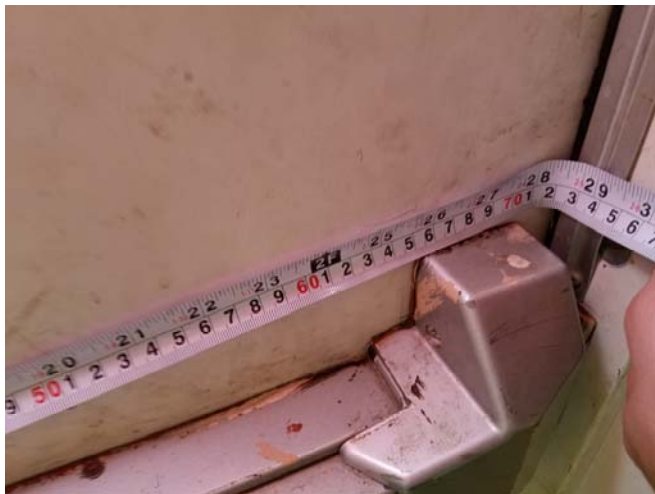
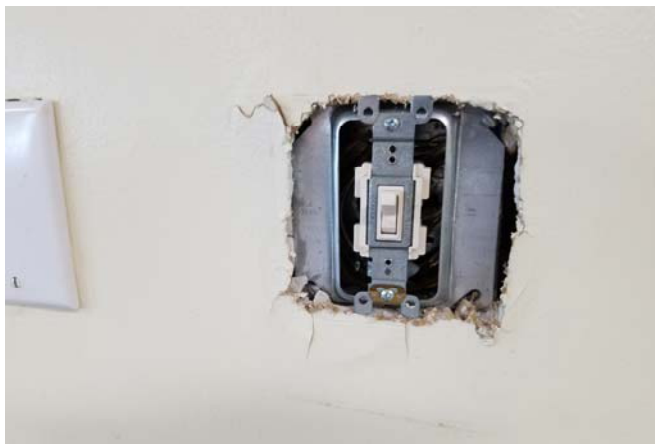
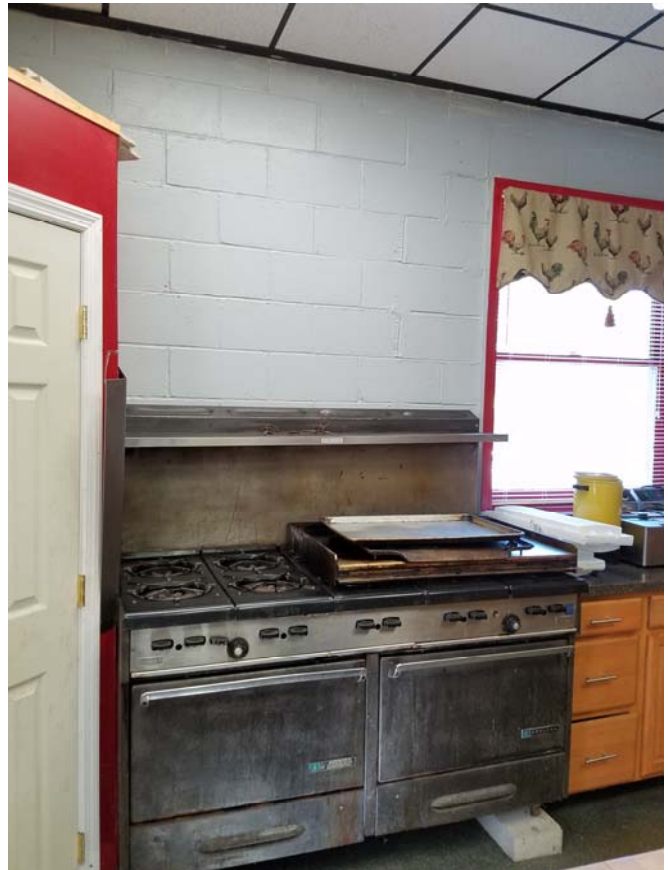
Storage Room Not Rated and > 100 SF

Missing Covers on Electrical Boxes

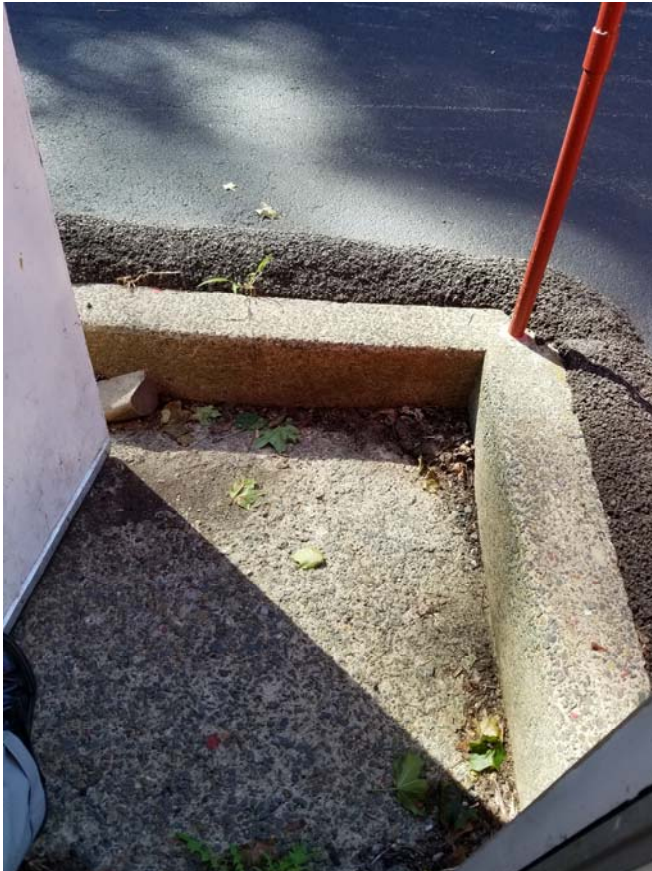
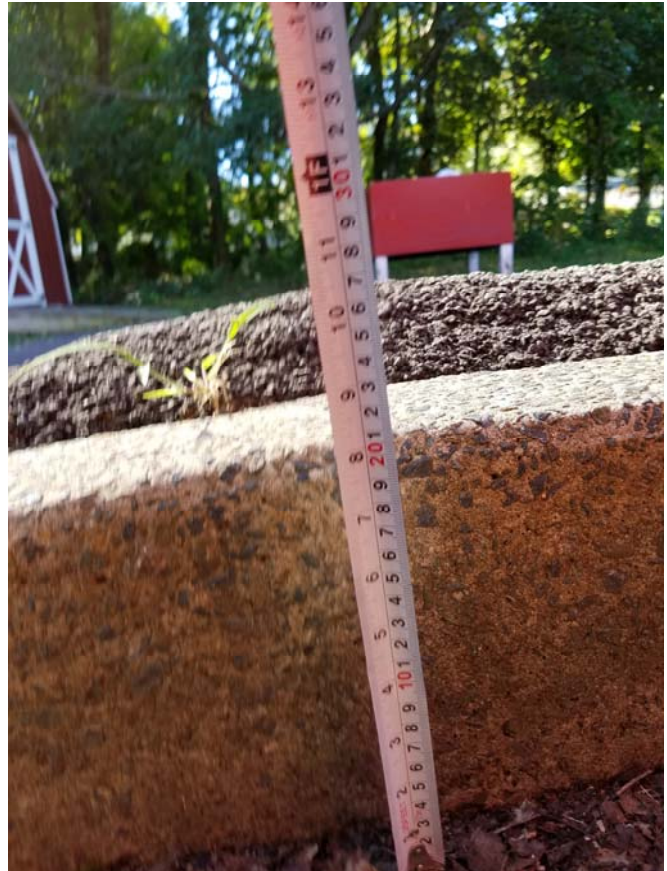
South Egress Door No HDPC Approach and too Narrow: 28 1/2"

Door Has 10" Step Up at Exterior
